# Manhole Inspection Summary

Manhole # S25A\_\_033MH

Insp Date: **8/20/07 9:25 AM**

**Location** Address: **614 CAREY-STOCKTON**

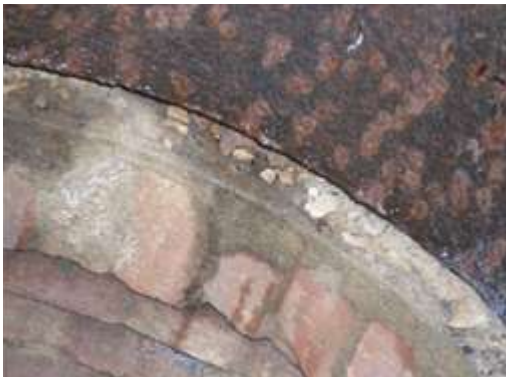
Defect 2

Condition: ☐ Sound ☐ Cracked ☐ Root Intrusion ☐ Loose Brick ☒ **Deteriorated**

DETERIORATION OF CHIMNEY

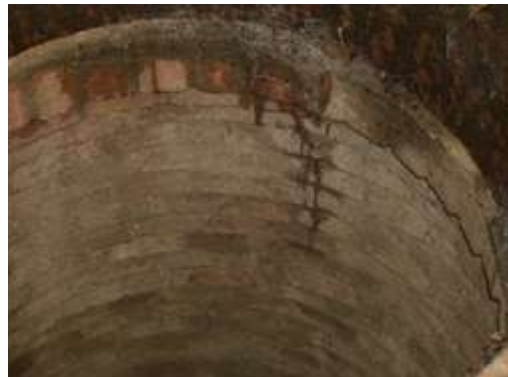
Defect 1

Infiltration: ☐ None ☐ Joint ☐ Cracks ☐ Mortar ☐ Roots ☒ **Wall**

CHIMNEY INFILTRATION

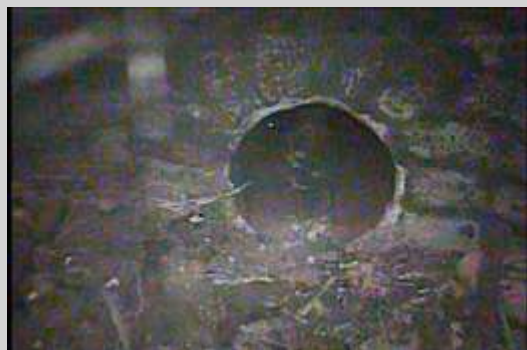
12 O'Clock Outflow

8 in. Circular Gravity Sewer  
Pipe Out @ 12 O'Clock

Infiltration: **None** Pipe Seal Cond: **Sound**
